THE UNITED STATES
STRATEGIC BOMBING SURVEY

THE EFFECTS
OF
THE ATOMIC BOMB
ON
HIROSHIMA, JAPAN

Volume III

Physical Damage Division

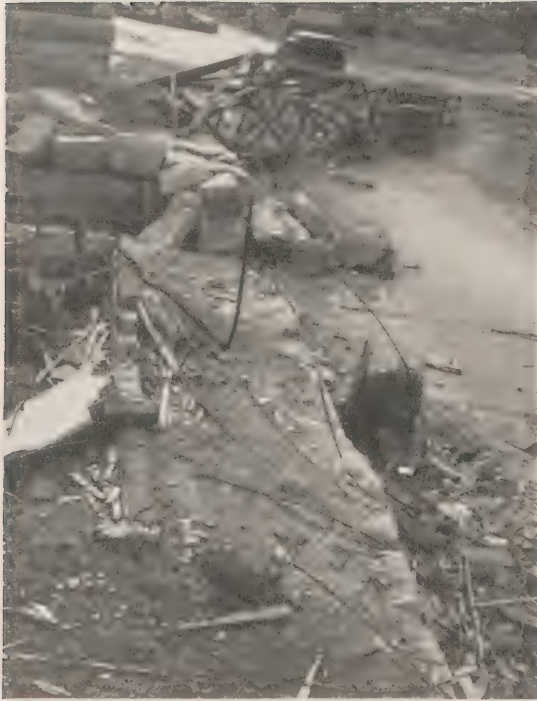
and fire. (NOTE.—In the following pages, photos with an asterisk (*) will be found in Part A, and those marked with a number sign (#) will be found in Part C of Sec. XIII.) Of the 6,400 wood poles (Type 1), 500 were broken by blast (Photos *16, 76, 77, 78, 79, 80, 81, 82, and 84), and 3,500 were burned (Photos 82, 85, 87, and 88). Of the 30 steel-lattice poles (Type 3) 6,000 feet from GZ, 27 were damaged by blast (Photos *17, *19, *22, 76, and 77), having been bent at the base. No concrete poles (Photo *23) were damaged, the nearest concrete pole being 6,000 feet from GZ. Overhead transmission wires were found parted and down 8,000 feet from GZ as a result of blast (Photos *86 and *88). The limits of damage to the types of poles of the Chugoku Electric Co. are shown on Table 19.

PHOTO 77-XIII. Steel lattice and wood pole 2,000 feet from GZ. Framing members of Bridge 30A also damaged at this distance.

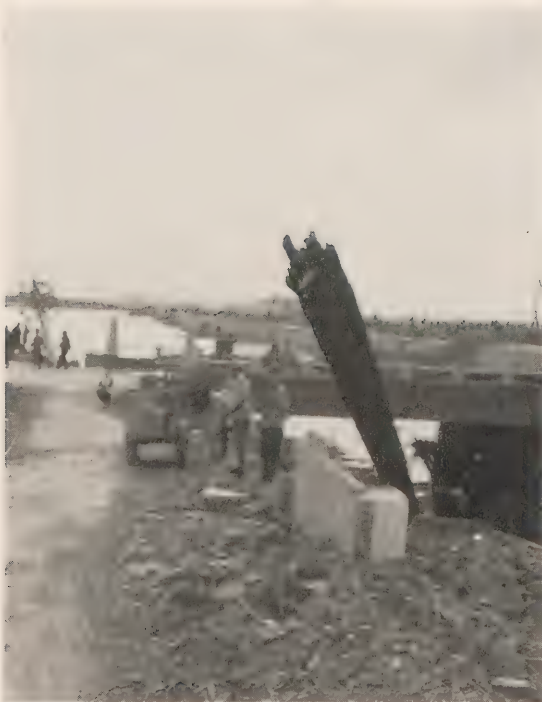
PHOTO 78-XIII. Wood poles 3,000 feet from GZ.

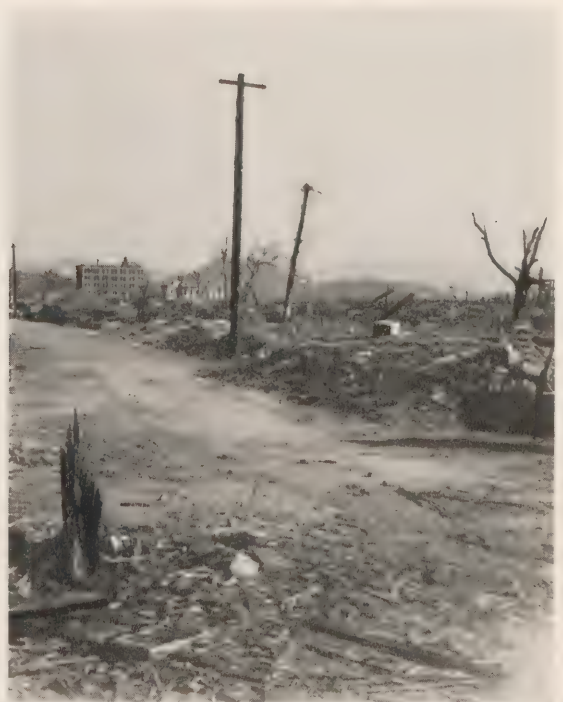
PHOTO 79-XIII. Wood poles 3,000 feet from GZ.

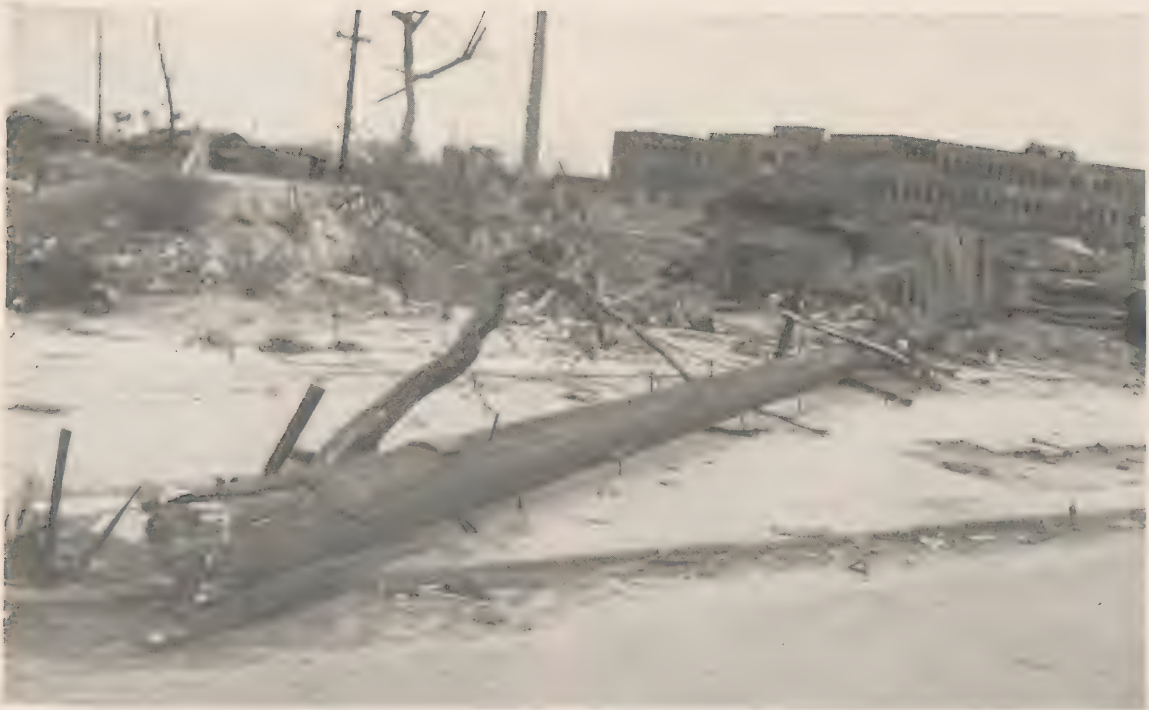
PHOTO 80-XIII. Wood pole down at 4,000 feet from GZ.

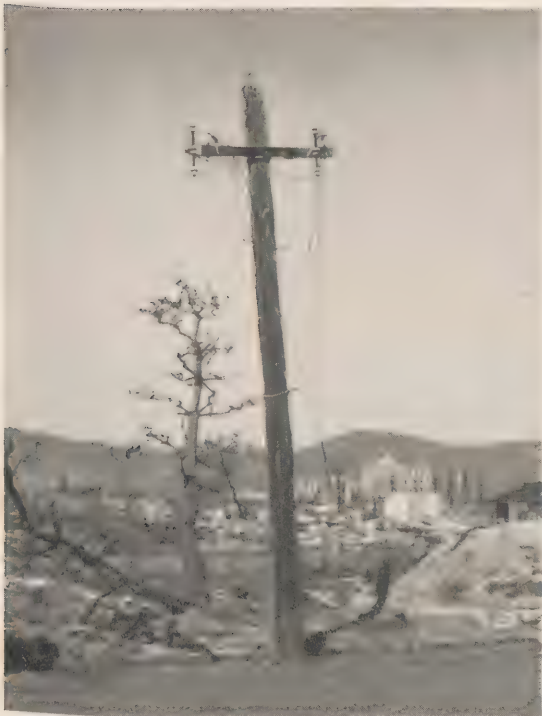
PPOTO 81-XIII. Broken wood pole 4,500 feet from GZ.

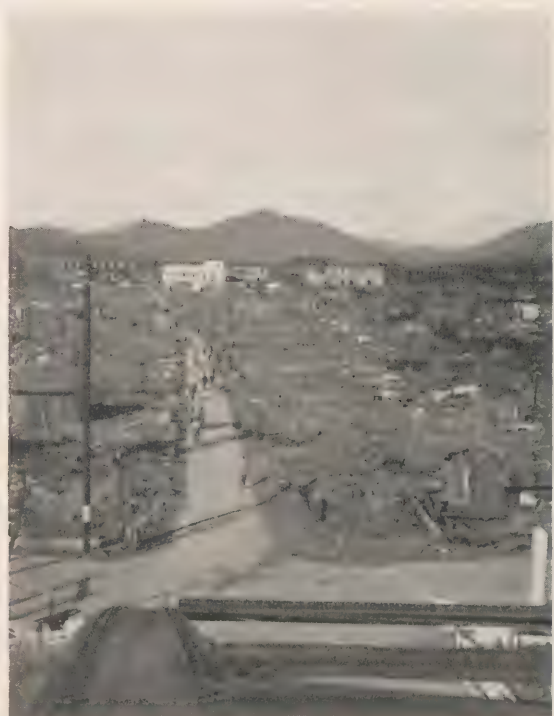
PHOTO 82-XIII. Burned poles 4,500 feet from GZ.

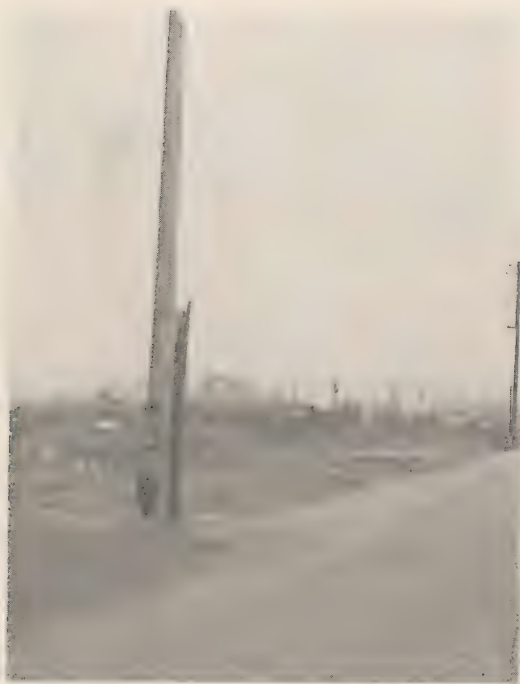
PHOTO 33-XIII. Broken and replaced wood pole 4,500 feet from GZ.

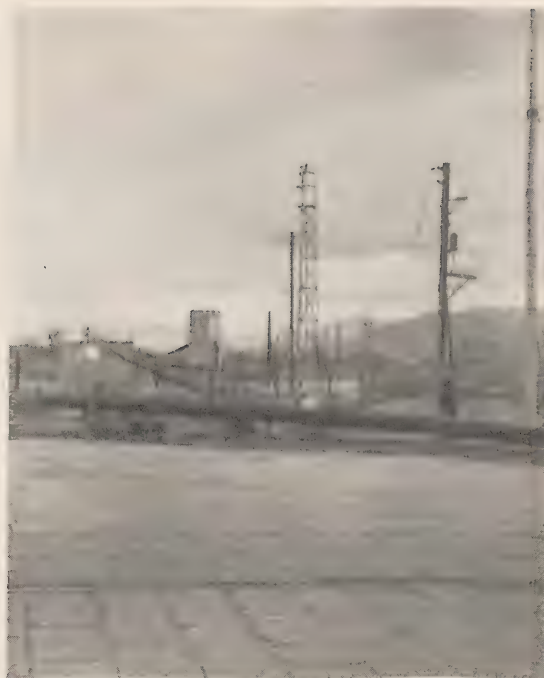
PHOTO 84-XIII. Broken wood pole at 4,500 feet from GZ.

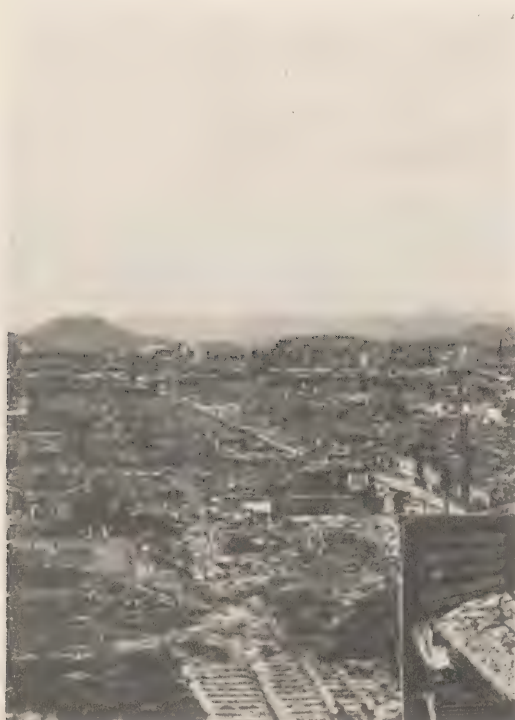
PHOTO 85-XIII. Burned poles at 5,500 feet from GZ. This area was 40 percent built up. Burning of area resulted also in burning of poles.

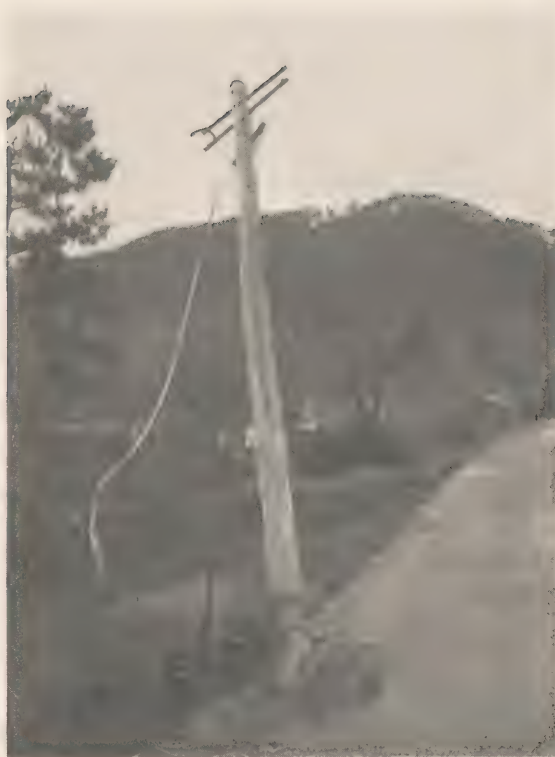
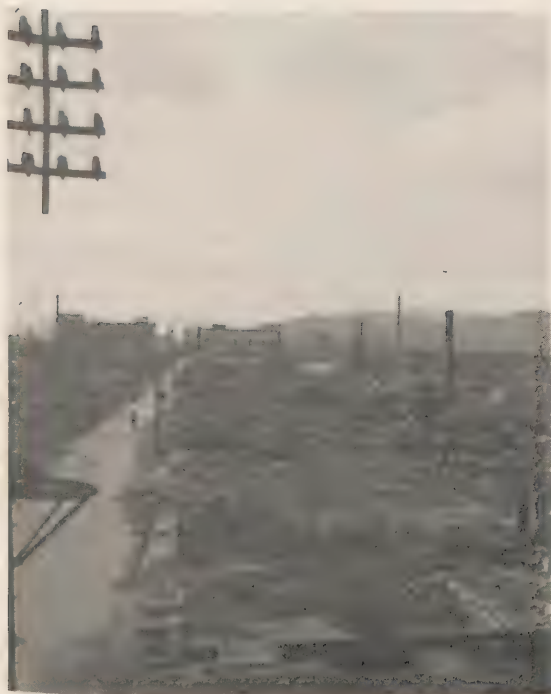
PHOTO 86-XIII. Tilted wood poles 7,000 feet from GZ. Note flash burns and severe tilt away from blast.

PHOTO 87-XIII. Charred poles 7,500 feet from GZ.

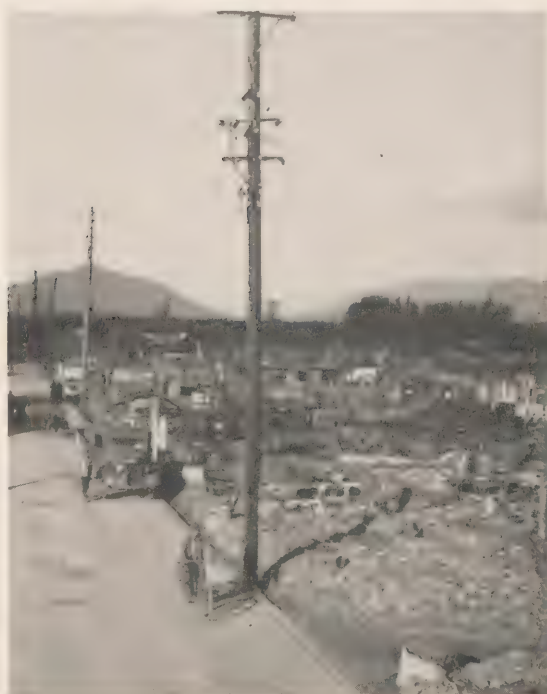
PHOTO 88-XIII. Scorched poles and wire down 8,000 feet from GZ.

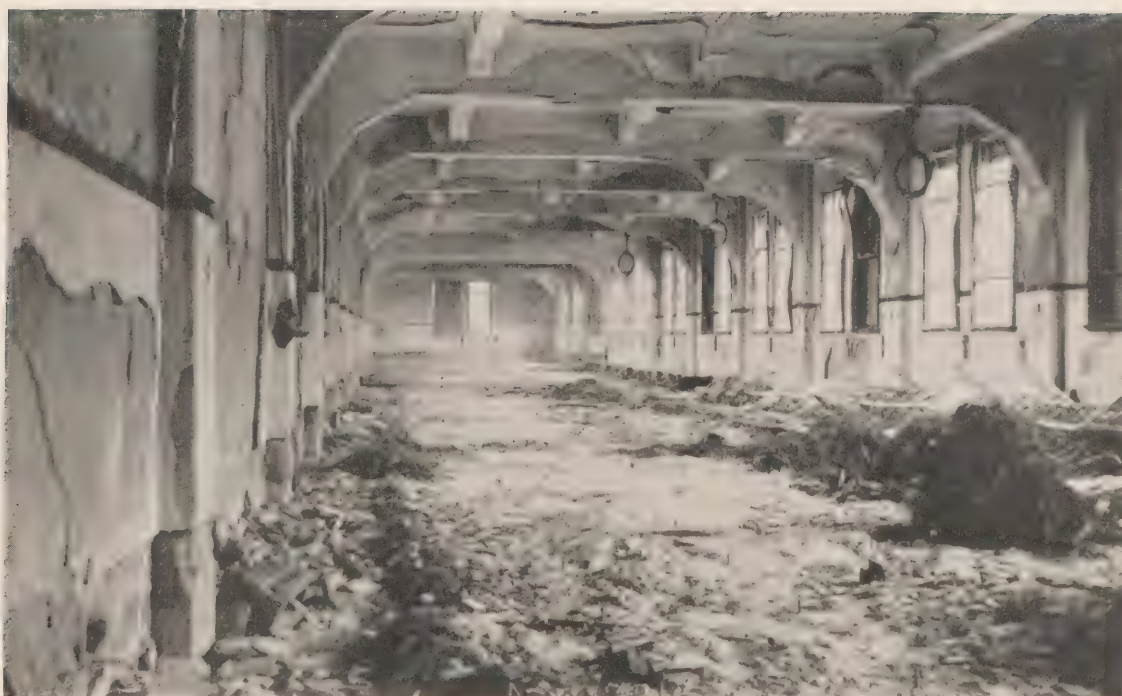
a. The Central and Western Districts Exchange Buildings were listed as Buildings 43 (Photo 89) and Building 85 (Photo 91), respectively, by the Building Damage Section, and the damage analysis for these buildings is contained in that

PHOTO 89-XIII. Bureau of Telephones' Central District Exchange Building showing damaged equipment, 2,000 feet from CZ.

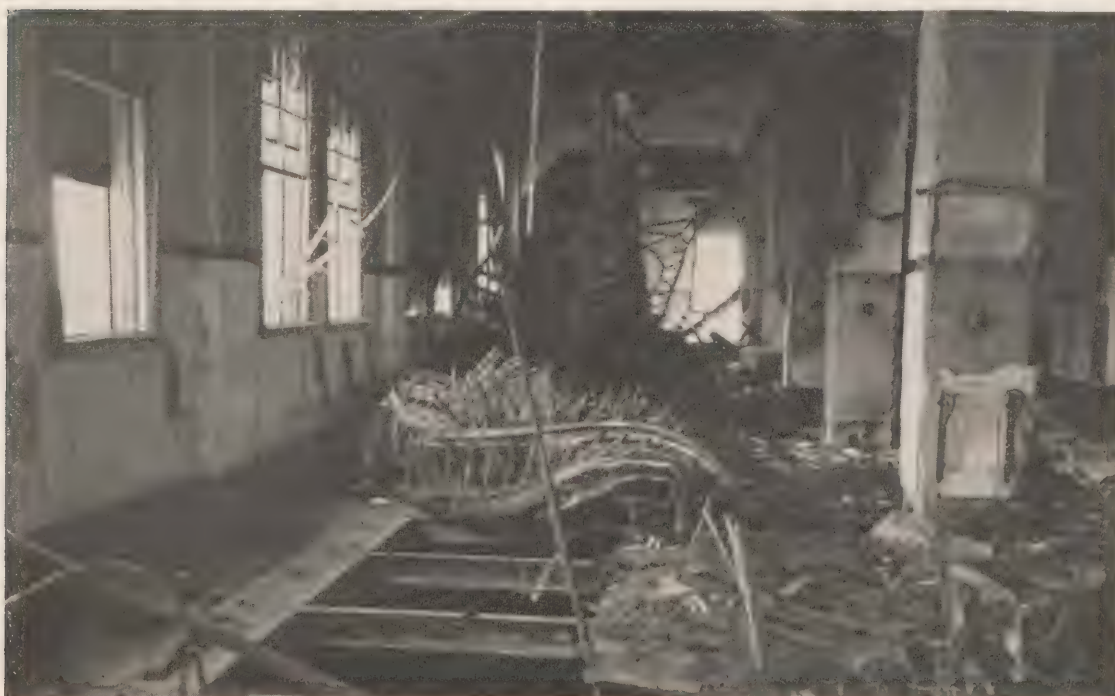
b. The equipment in the Central District (Photo 90) and the Western District (Photo 92) Exchange Buildings, which were 2,800 and 3,800 feet, respectively, from AZ, was initially damaged by blast. Short circuits from damaged equipment started fires that totally damaged the equipment in the Central District Exchange Building. Eyewitnesses stated that the equipment was afire immediately after the explosion, corroborating a statement made by the chief engineer of the Bureau of Telephones. Since the equipment was on the opposite side of the building facing AZ, adequate protection from radiant heat was afforded by the concrete slabs. It was therefore concluded that short circuits were the cause of the fire, which was in agreement with the Japanese. The equipment in this exchange was of the old, open type and burned freely; the Western District Exchange equipment, being of recent manufacture, was enclosed and the damage due to blast and short circuit fires was reduced to 50 percent, but the damage was sufficient to halt all telephone communications. Blast and fire destroyed approximately 7,000 telephones.

PHOTO 90-XIII. Equipment damage in the Central District Exchange Building.

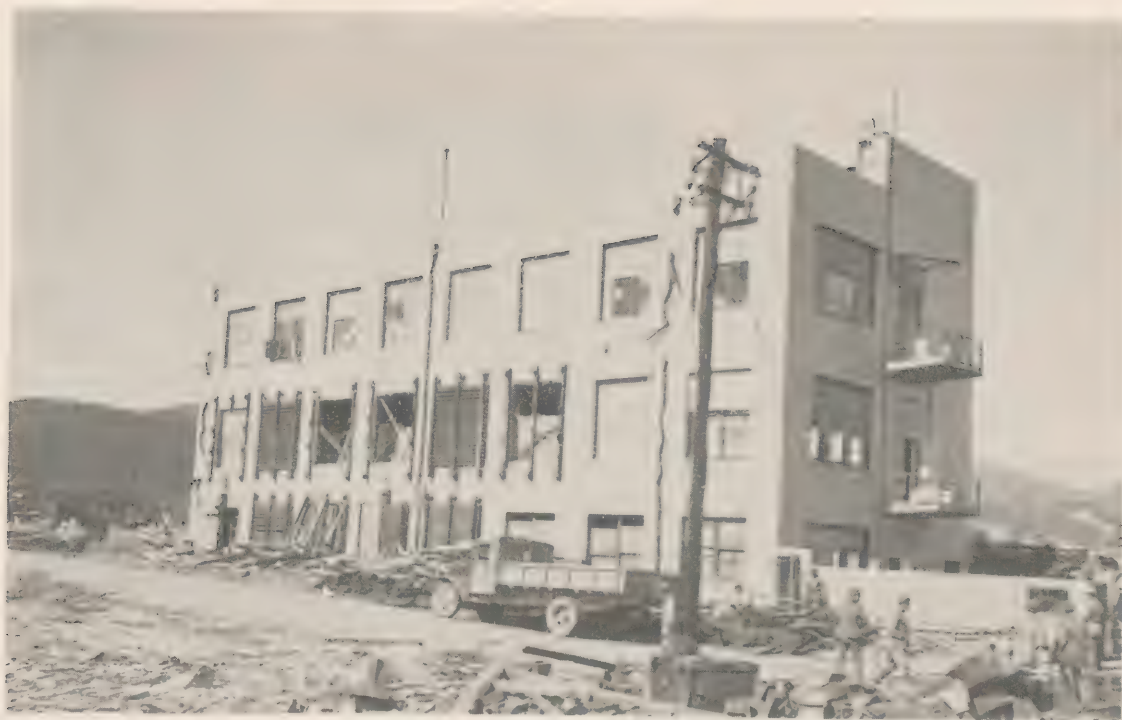
PHOTO 91-XIII. Bureau of Telephones' Western District Exchange Building, 3,300 feet from GZ.

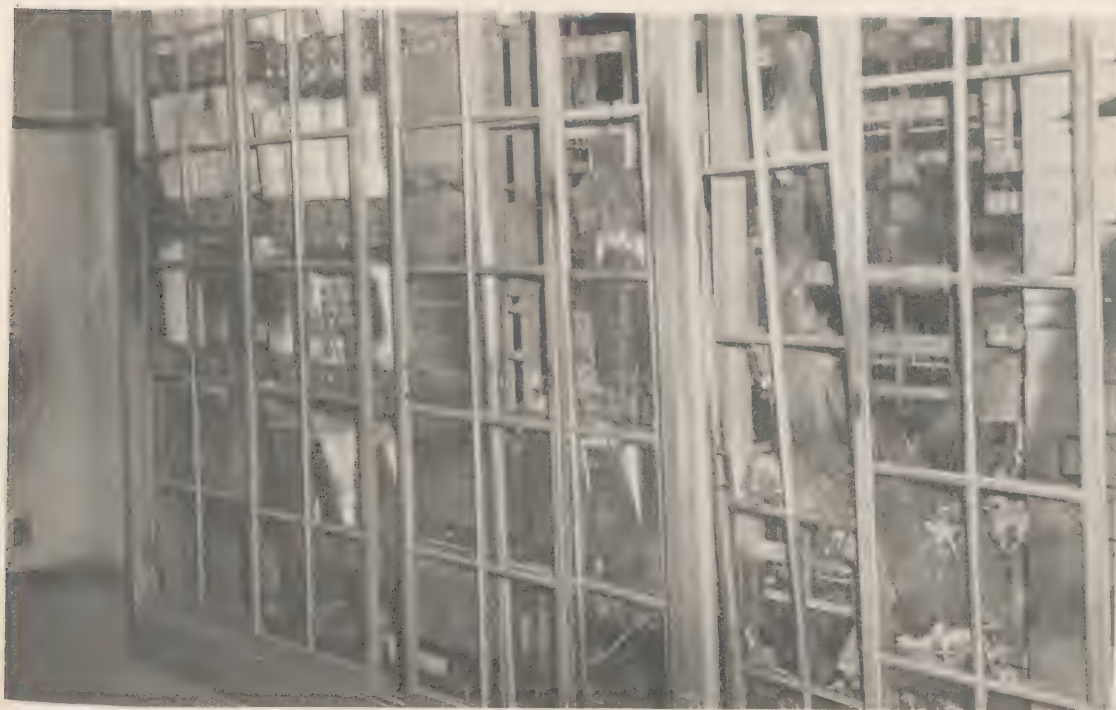
PHOTO 92-XIII. Equipment damage in the Western District Telephone Building.

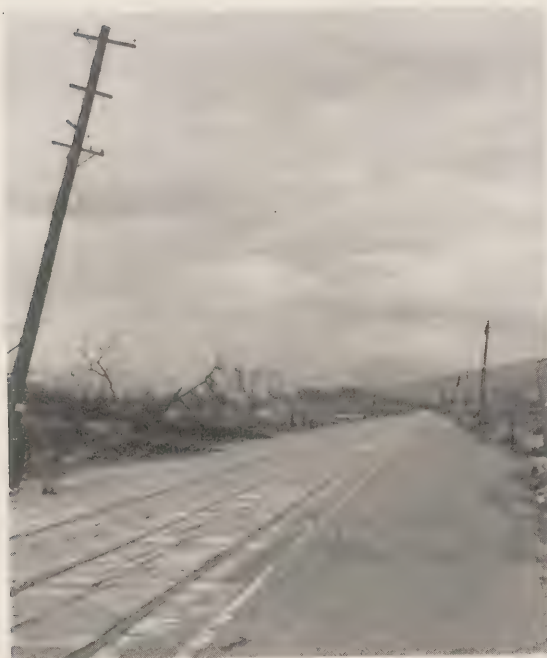
c. The greatest damage to the telephone transmission system was in the overhead section (Photos *16, *17, *18, *22, *23, and 94 through 98). The majority of poles, being wood, were downed by blast or were consumed by the fire that followed. Lead-sheathed cables were totally damaged by fire, being consumed up to the point of entry of the subsurface system (Photo 93). Wood poles (Photo #87) were broken off at varying heights up to 4,500 feet from GZ and were burned (Photo #85) at a distance of 6,500 feet from GZ. Cable (Photo 98) was stripped from the hangers at a

PHOTO 94-XIII. Damaged wood pole and cable, 2,500 feet from GZ.

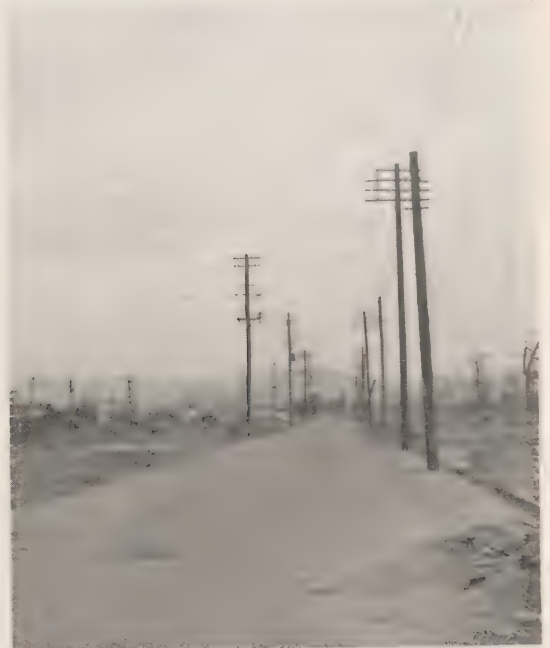
PHOTO 95-XIII. Stripped cable 4,500 feet from GZ.

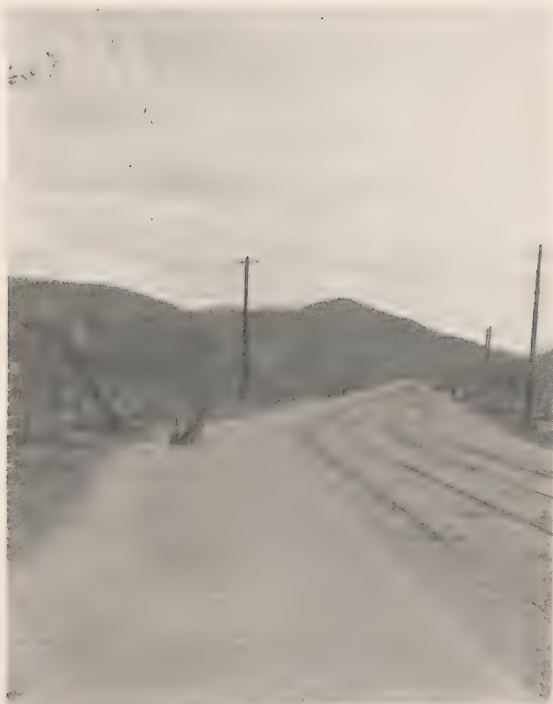
PHOTO 96-XIII. Steel-lattice poles, 6,000 feet from GZ. Poles were downed by blast across road, but were removed to make way for traffic.

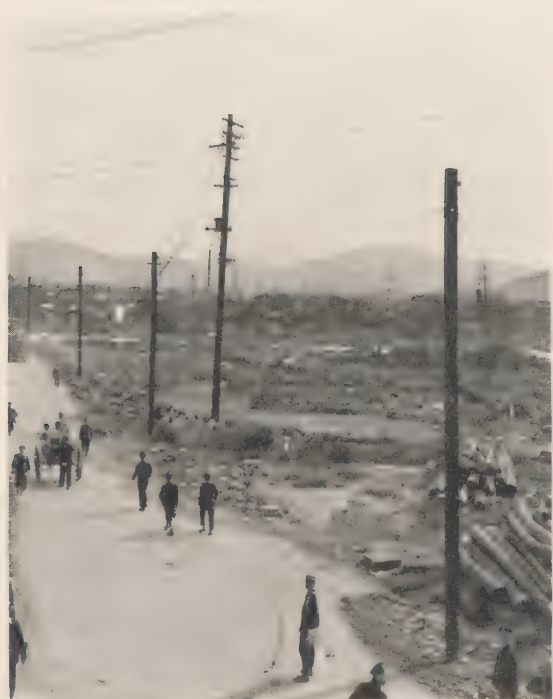
PHOTO 97-XIII. Damaged cable, 7,500 feet from GZ.

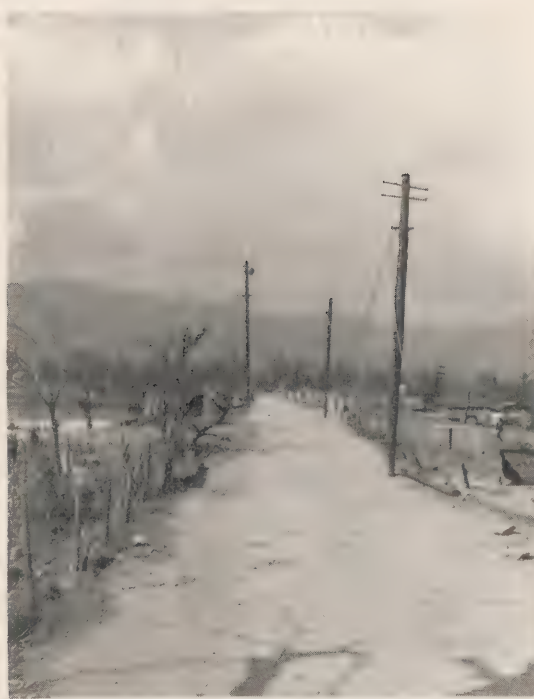
distance of 8,000 feet from GZ, but the poles were upright and the cable was otherwise undamaged. Figure 13 indicates the extent of damage to the overhead system and shows the distances to GZ. Table 24 lists damage to the overhead transmission system.

PHOTO 98-XIII. Cable downed, 8,000 feet from GZ.

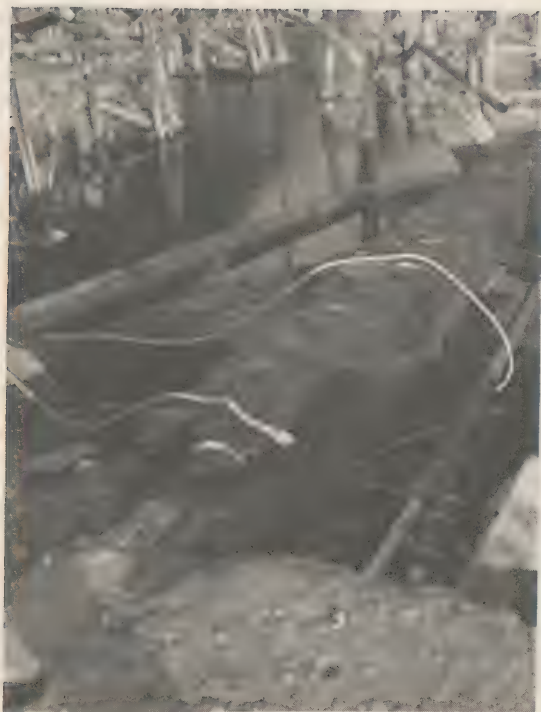
PHOTO 99-XIII. Damage to cable at Bridge 13A, 4,700 feet from GZ.

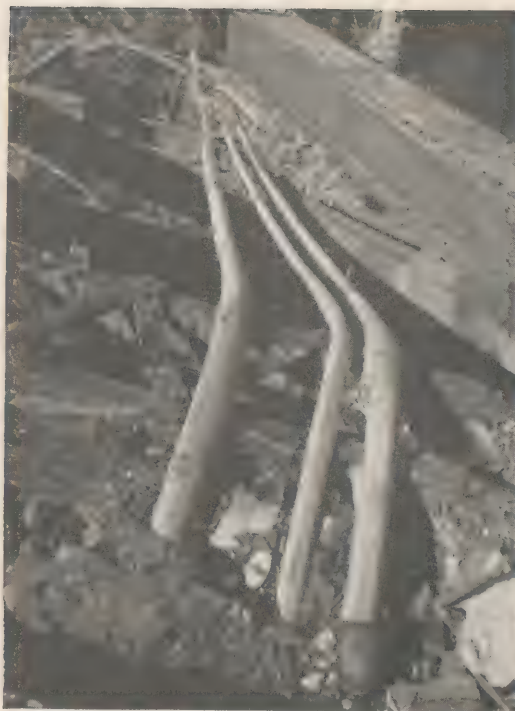
PHOTO 100-XIII. Damage to 2,000-pair cable at Bridge 29, 1,200 feet from GZ.

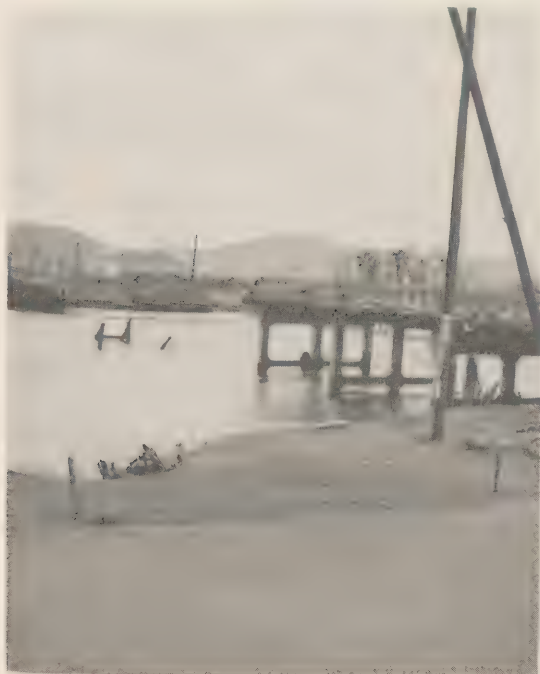
PHOTO 101-XIII. Flood damage to Bridge 31 carrying 100-pair cable, 4,600 feet from GZ.

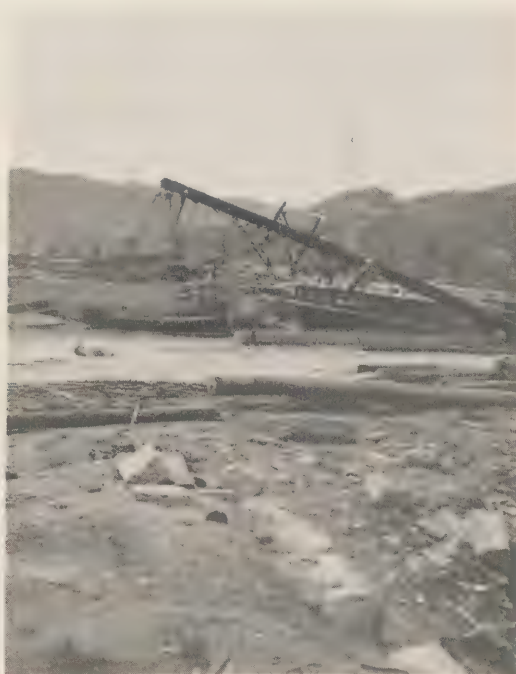
PHOTO 102-XIII. Flood damage to Bridge 37 carrying 1,000-pair cable, 3,200 feet from GZ.

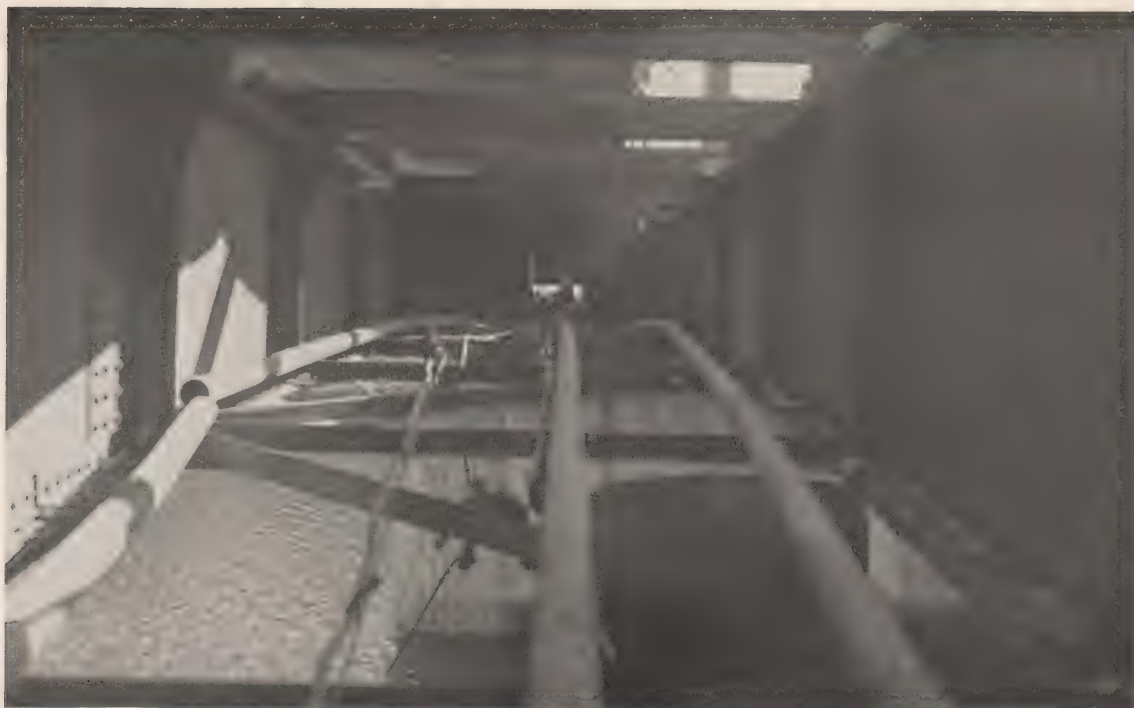
Figure 13 shows the location of the damaged bridges. Although Bridge 24 was not down (Photos 103 and 104), the severe blast effects parted the transmission cables. There was no damage to subriver crossings. Thus, the several types of damage put out of service the cables in each district as given in Table 26.

PHOTO 103 XIII. Damage to telephone conduit cable at Bridge 24, 1,000 feet from GZ.

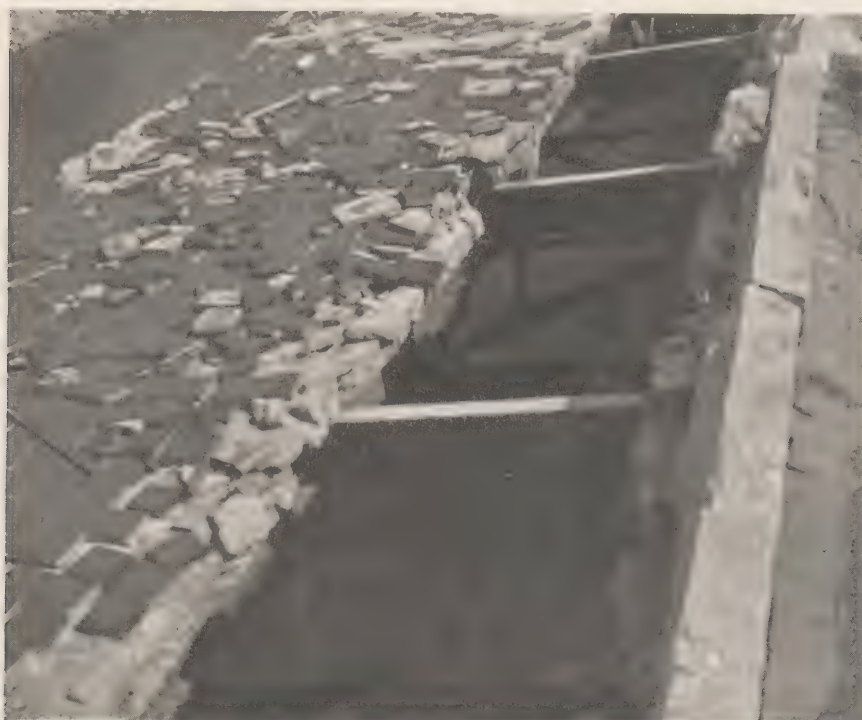
PHOTO 104-XIII, Broken cable conduit at Bridge 24.

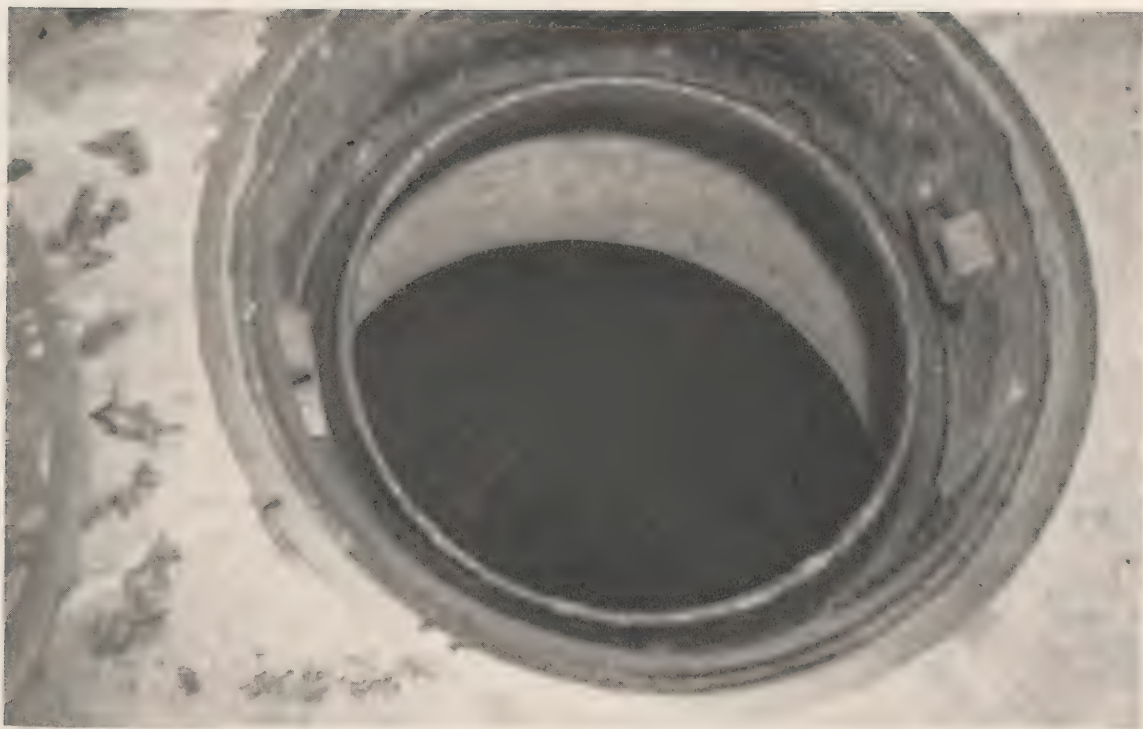
The remaining bridges were undamaged. Additional repairs had to be made and circuits rerouted. As explained in the Sanitary and Storm Sewer Section of this report, water tables that were normally 8 to 12 feet below ground elevation rose to within 3 feet of ground elevation (Photo 105). Since manholes were neither water-proofed nor drained, water seeped through the concrete walls and saturated the conduits. This caused more delay in the repair of the remaining subsurface system. Cables, being lead-sheathed and well protected at manhole intersections, were not water damaged. The telegraphic system under the Bureau of Telegraphs was totally damaged, and the system was merged with the Bureau of Telephones. One telegraph line communicating with Tokyo and Osaka was operating by the middle of September 1945.

PHOTO 105-XIII. Water-filled, telephone manhole.

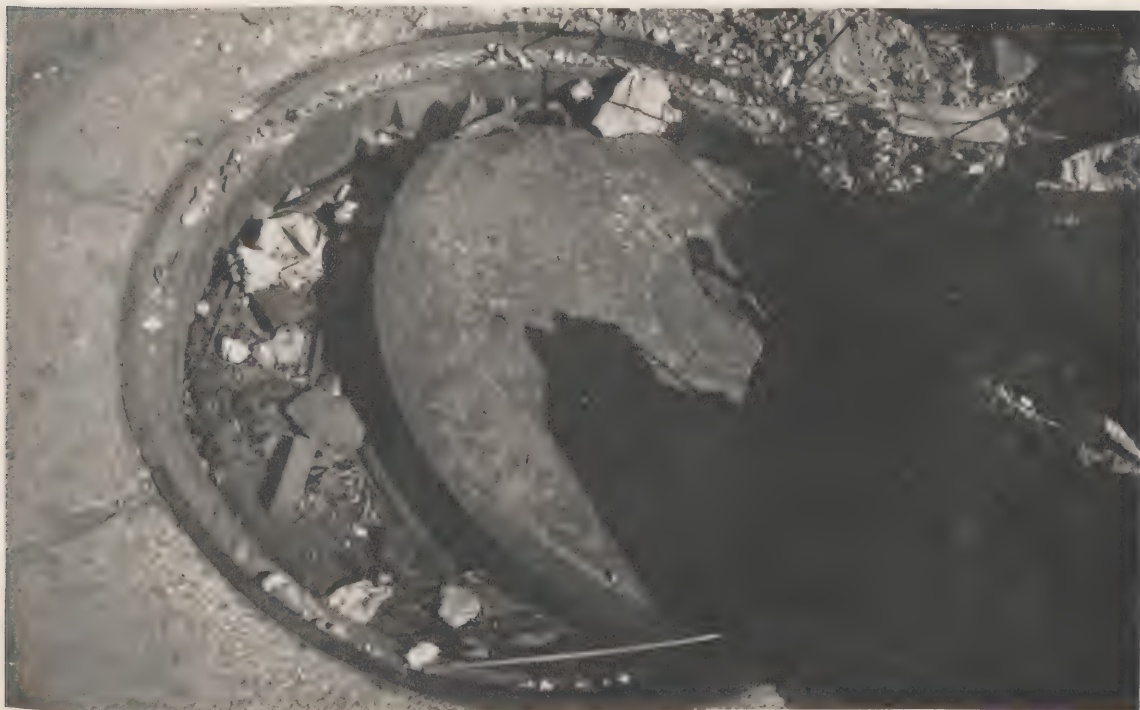
PHOTO 106 XIII. Debris-damaged telephone manhole cover 100 feet from GZ. Secondary cover undamaged.

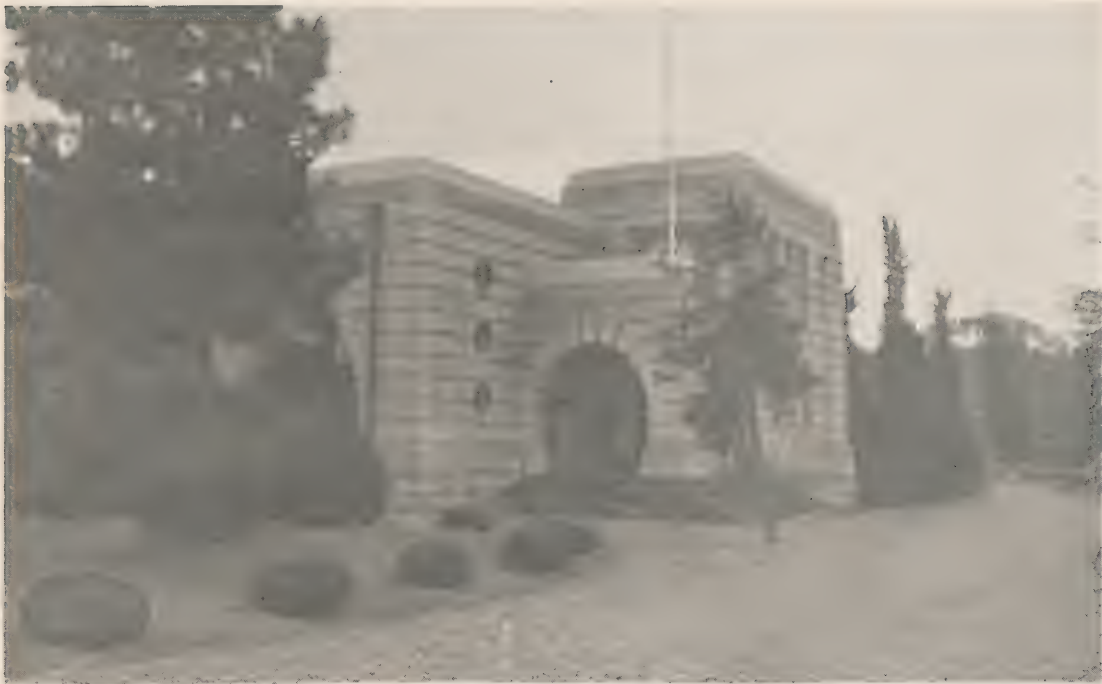
a. The damage to the pumping station (Photo 107) and purification plant (Photo 108), buildings and equipment (Photos 109, 110, and 111), 14,000 and 9,200 feet from GZ, respectively, on 6 August 1945 can be considered as negligible. All damage suffered by buildings (Photo 112) and equipment was by blast. No fires started in this area. Glass panes in all buildings were broken by the blast, as well as window frames, doors, and door frames. Some roof stripping occurred on Buildings 3, 4, and 6 (Photo 113). Sidewall damage occurred to Building 8. All building damage is indicated on Table 28.

PHOTO 107-XIII. Pumping station Building, 14,000 feet from GZ. Windows broken by blast.

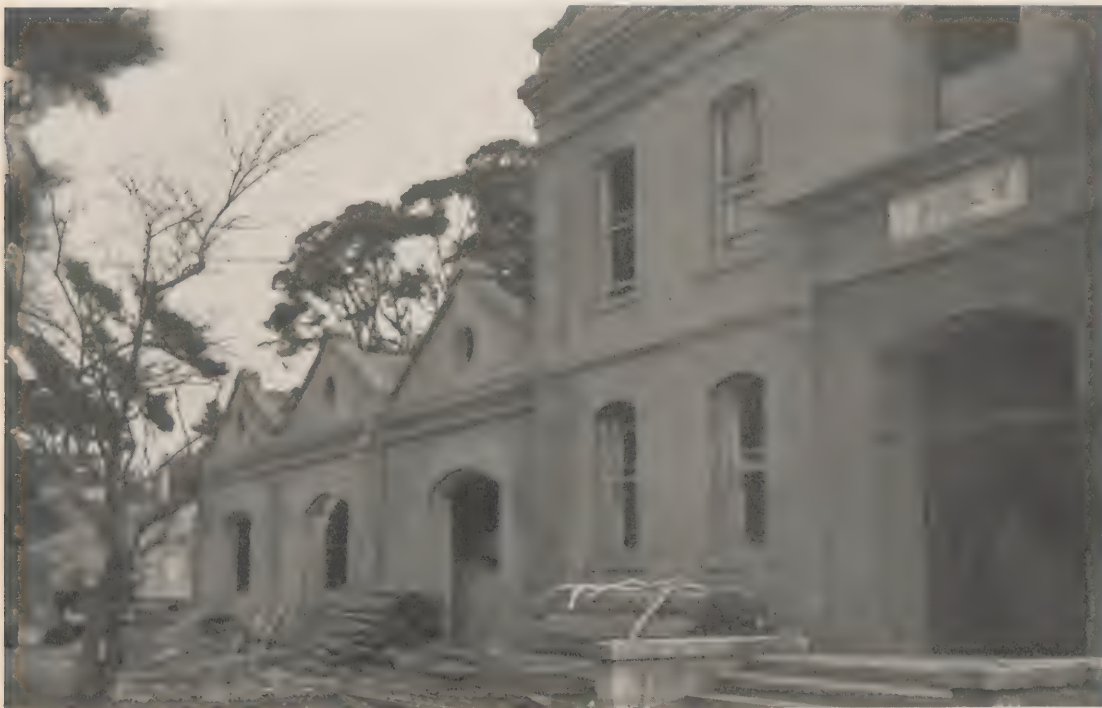
PHOTO 108-XIII. Diesel pumping plant, Building 3, 9,000 feet from GZ, showing window frames damaged by blast.

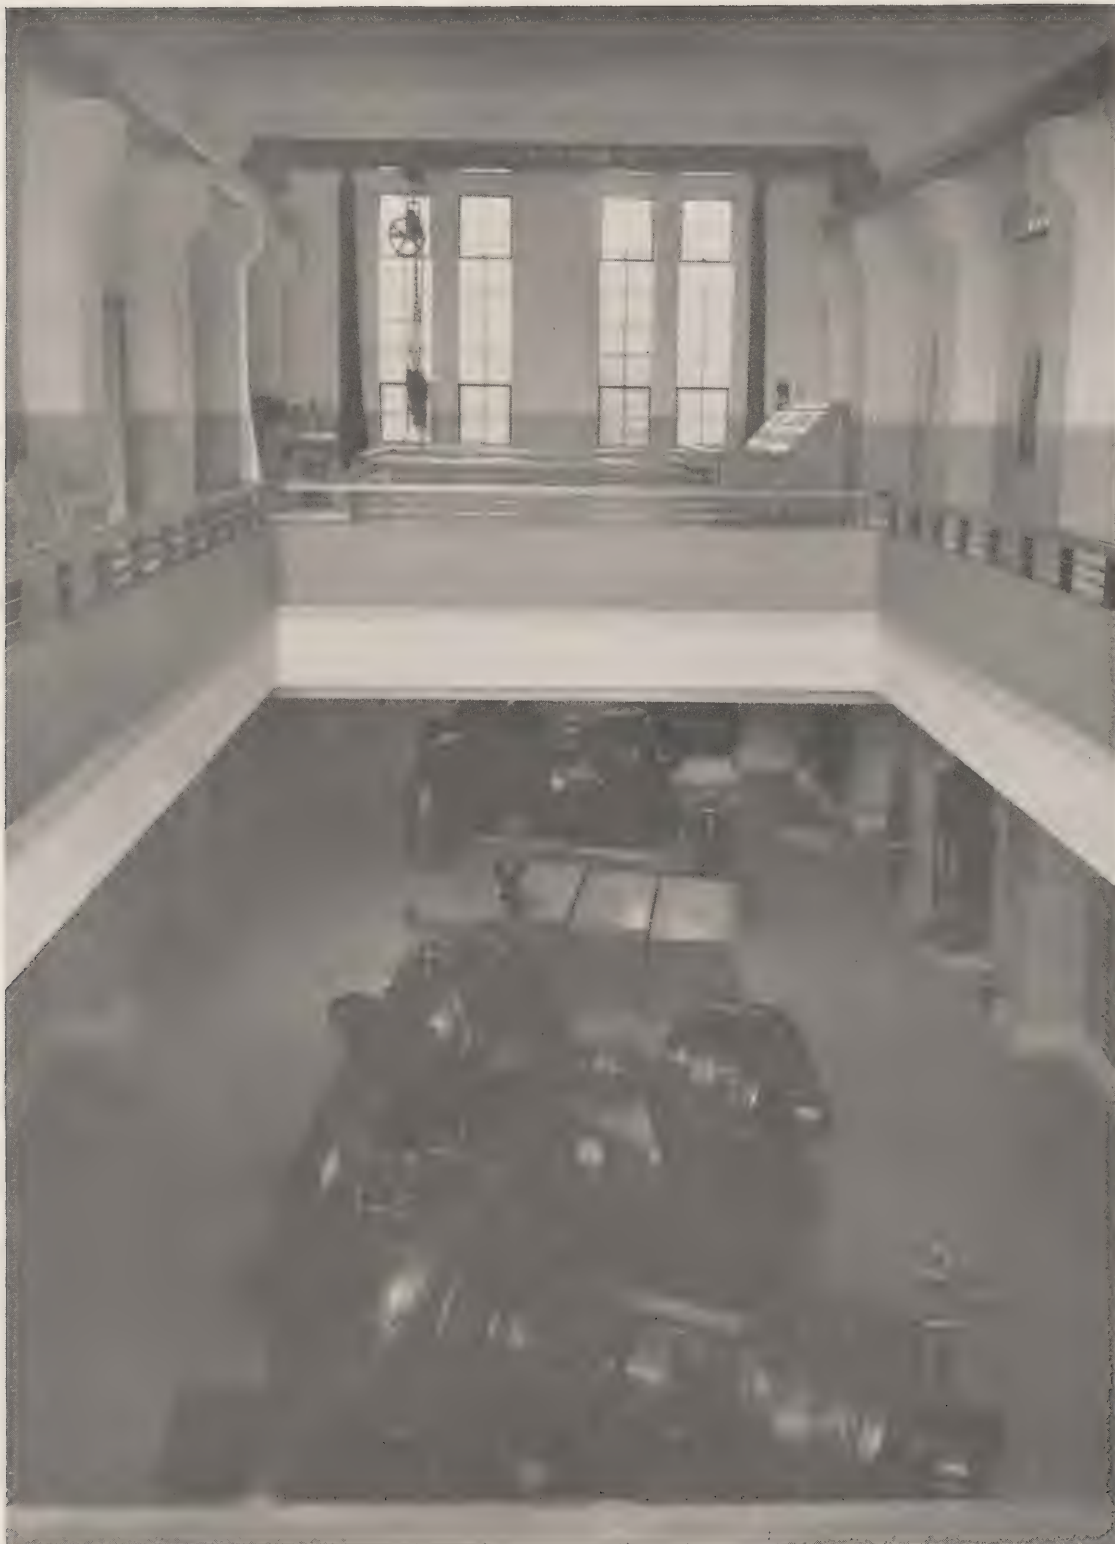
PHOTO 109-XIII. Equipment and electrical panel at pumping station, 14,000 feet from GZ.

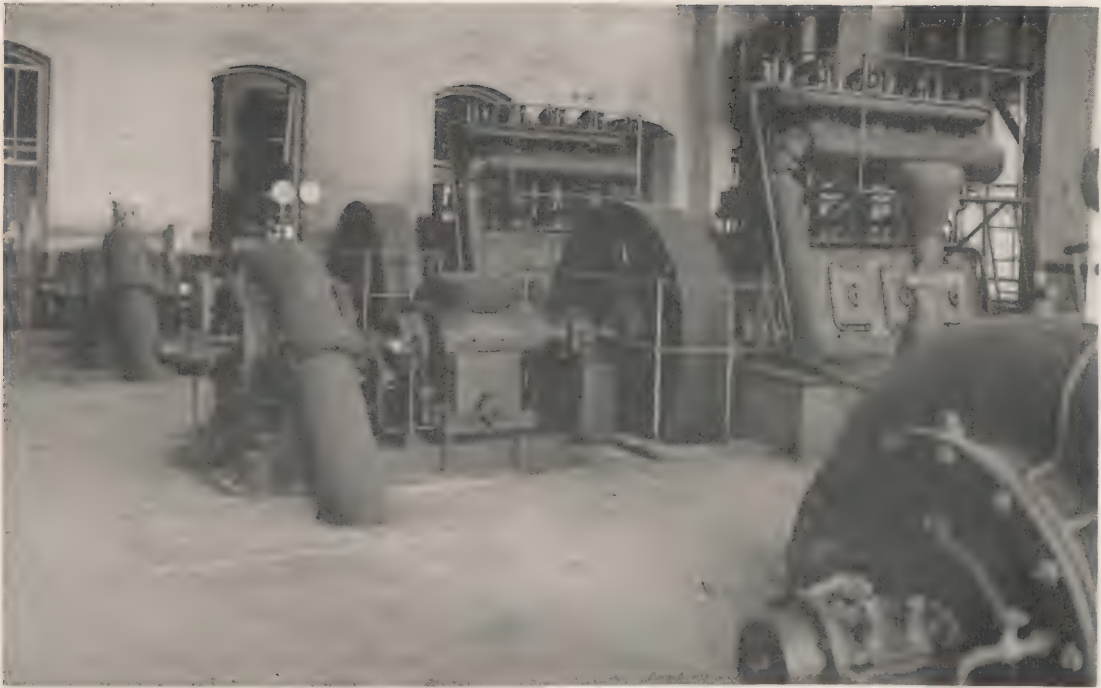
PHOTO 110-XIII. Diesel pumping plant, Building 3, showing pumping equipment, 9,000 feet from GZ.

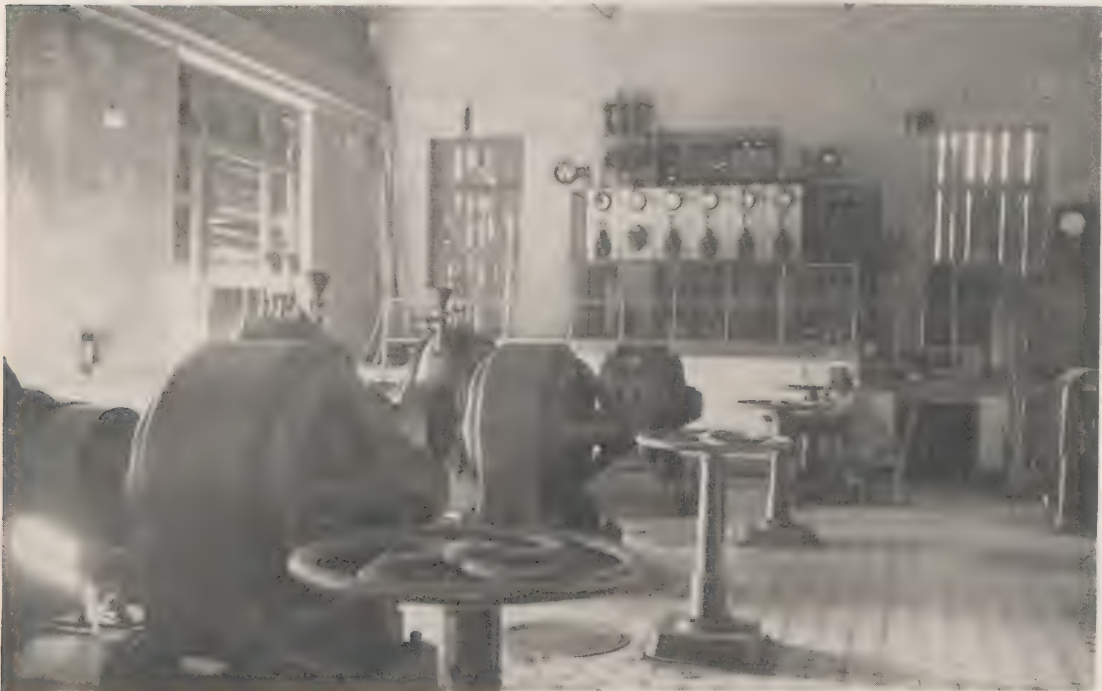
PHOTO 111-XIII. Undamaged pumphouse, Building 6, equipment and switch board panel, 9,000 feet from GZ.
